# Manhole Inspection Summary

Manhole # S49M\_\_010MH

Insp Date: **4/15/08 3:52 PM**

**Location** Address: **2639 hudson st**

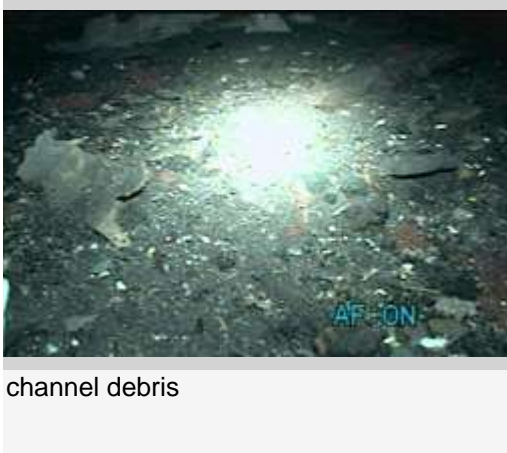
Defect

Condition: ☐ Sound ☐ Cracked ☐ Root Intrusion ☐ Deteriorated ☐ Leaks ☒ **Debris**

channel debris

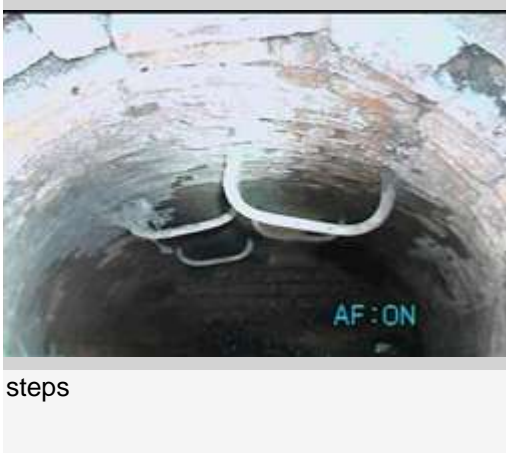
Defect 2

Count: **4** Missing: **0** ☒ **Corroded**

steps

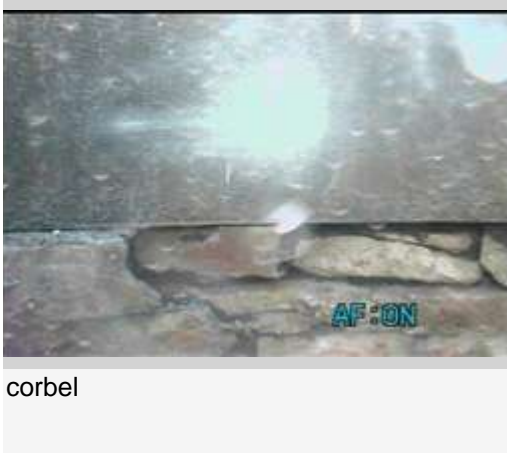
Defect 1

Condition: ☐ Sound ☐ Cracked ☐ Root Intrusion ☒ **Loose Brick** ☐ Deteriorated

corbel
